**2-6 Lacey Street, Kogarah Bay and 186-190 Princess
Highway, Beverley Park**

METHODOLOGY

Prepared by

RJC Stonemasons Pty Ltd

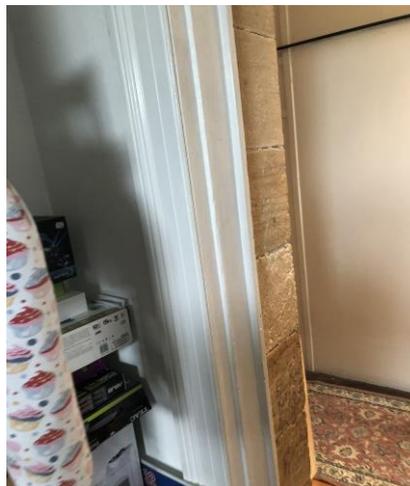
The internal stonework to the building is predominantly in reasonable condition. The sandstone blocks are in various lengths and bed height is 300mm in and around 450mm in depth. The depth is difficult to determine due to the rear of the hall way wall has a timber door frame around and the wall is covered in plaster. (See below).

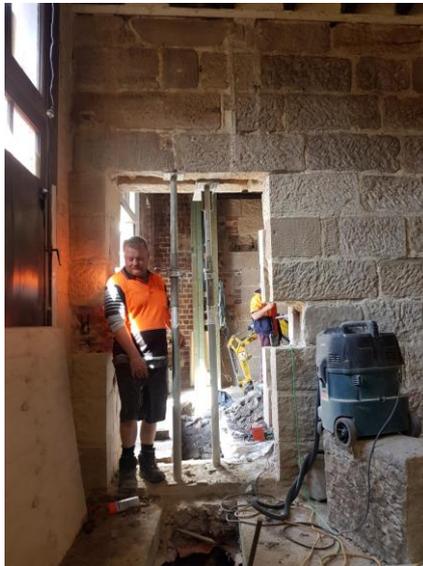
- The existing lintels on the two doorways have a good amount of stone bearing on the reveals on either side of the door openings.
- The existing 2 openings that require to be widened are 930mm wide and we require 1000mm to comply.
- We would install 4 strong boy props with Acrow props to support the courses over the sandstone lintels on both sides of the doorways. (see below).

- The props would then be wound up to take the weight of the existing sandstone lintel.
- The openings would be marked up, so we can cut the existing door reveals on both sides to allow the opening to be the required 1000mm wide.
- The door reveals would be cut with a stone chainsaw, so we would be able to cut right through the wall and using the chainsaw with diamond tipped chain this causes minimal vibration to the existing heritage fabric.
- Once the reveals have been opened to the required opening size, we would assess the bearing of the lintels on the existing reveals.
- We would require a minimum bearing of 150mm on both sides of the door openings.
- If we have one side of the stone lintel at a bearing of 200mm and the other side at 100mm, we will rake out the bed and perp joints and slide the lintel over, so we have 150mm on both sides of the door reveals.

- We would then re-dress the recently cut door reveals to match the original finish. We would reinstate the 18mm margin to the cut ends and pitch the face of the stone back to reinstate the rockface.
- Once all works have been signed off, we will remove the strong boys and repoint all bed and perp joints with traditional mortar to match the existing in colour and texture. The joints will be covered in blue painters' tape to prevent the mortar drying out too quick.
- All work will be washed down using clean water and new nylon bristled brush to any remove dust.
